Service Bulletin

American Honda Motor Co., Inc.

2006 GL1800 Airbag CB Radio Squeal

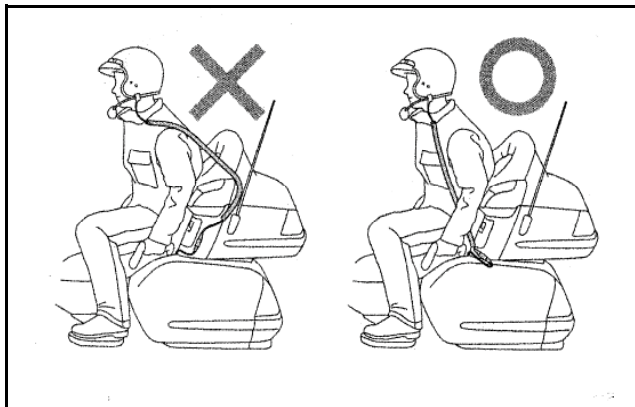
- The kit includes both a rider and a passenger harness; it's necessary to install both harnesses to eliminate the squealing noise.
- Passengers must route the headset cord as shown. If routed otherwise, it will be too close to the motorcycle's antenna, which can create an interference.

Install a ferrite harness core kit according to the installation instructions that are packaged with the kit.

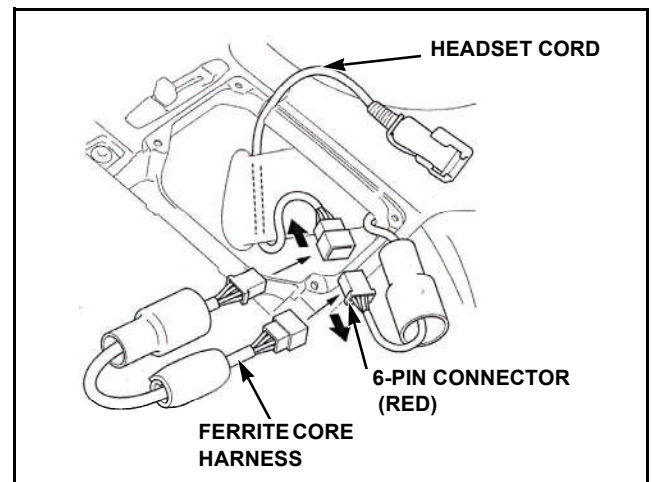
IDENTIFICATION

Subharness installation can be confirmed by removing the left-side fairing pocket, and checking to see if the harness is already installed.
