Service Bulletin

American Honda Motor Co., Inc.

2002 GL1800 Reverse Cable Inspection/Adjustment

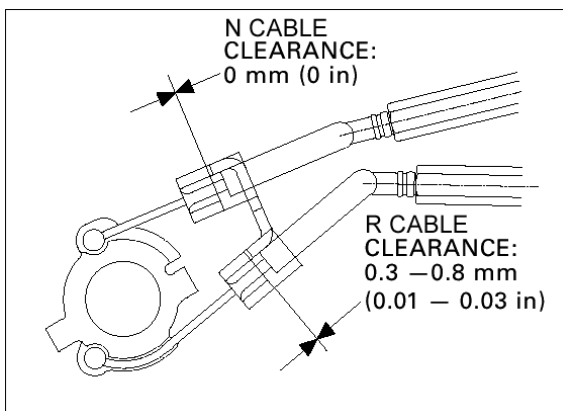
1. Remove the right engine side cover (see S/M Page 2-4).
2. Check the cable clearance on the N (neutral) and R (reverse) cables.

3. If adjustment is necessary, loosen the lock nuts and turn the adjusting nuts in the required direction (see S/M Page 18-35).
4. With the transmission in neutral, turn the ignition switch to the "ON" position and push the reverse shift switch to "ON".
5. Ensure there is clearance between the reverse shift arm and lost motion plate.
