Service Bulletin

2012 GL1800/A Navigation System Software PRODUCT UPDATE CAMPAIGN

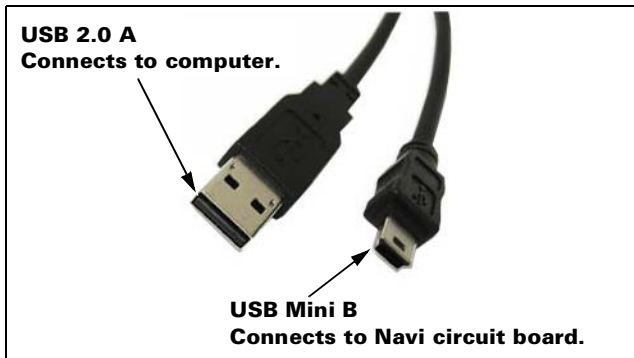
- Confirm the laptop PC to be used is running Windows XP, Vista, or Windows 7.
- Confirm that a file compression utility such as WinZip is installed on the computer.
- Use a USB 2.0A to USB Mini-B cable (typically provided with many digital cameras or tablet computers), and plug it into a USB port.

Cable is available from Radio Shack:
 Model: 27329 | Catalog #: 55010682

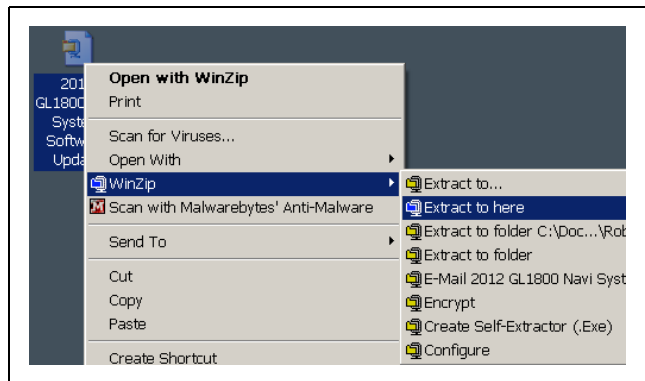
3. Right click on the Zip folder and choose *Extract to here*.

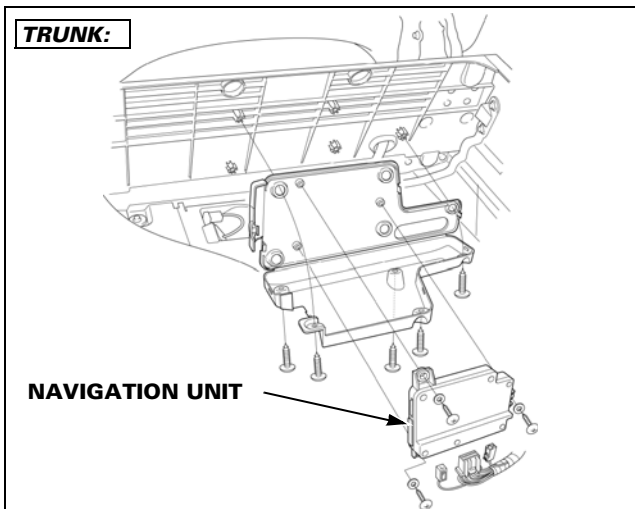
1. Using the procedure on page 23-45 of the Service Manual, remove the navigation unit from the motorcycle.

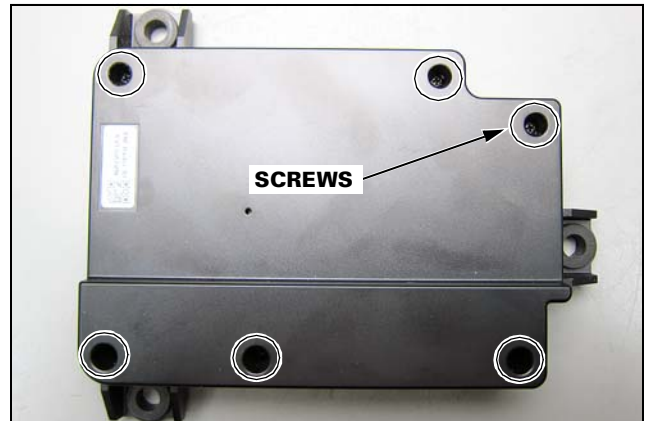
2. Remove the six screws and cover from the navigation unit.

12. Turn the ignition switch to OFF and reinstall the navigation unit cover and six screws.

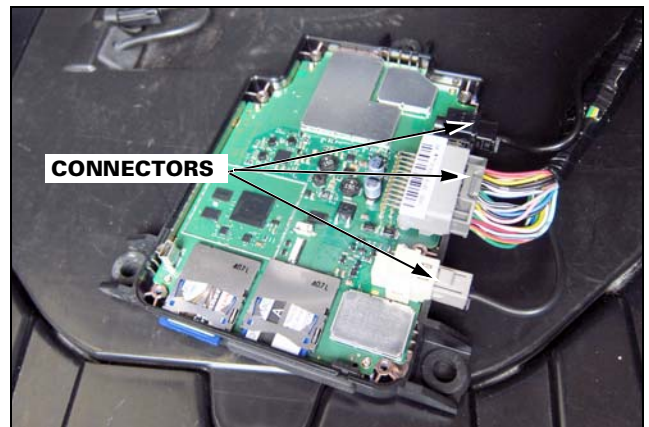
3. Re-connect the 24P (Gray), GPS antenna, and XM antenna connectors to the navigation unit as shown.

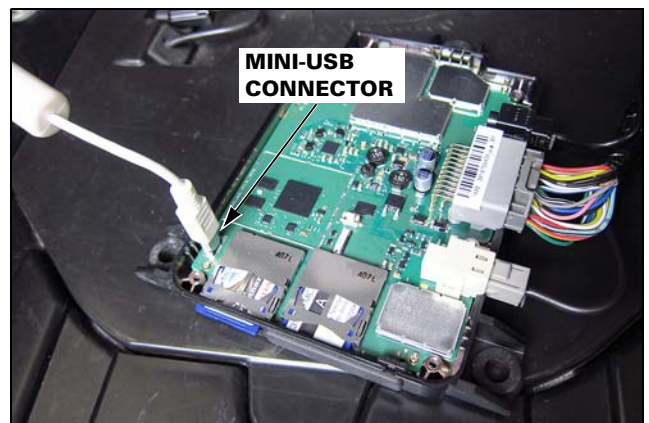
4. Connect the navigation unit to the PC with the USB cable as shown.

Insert the mini-USB connector into the socket on the navigation unit circuit board. Confirm the other end of the cable is connected to a USB port on the PC.

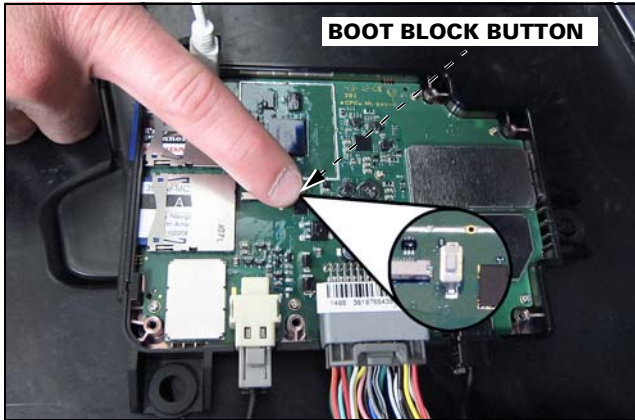
5. Press and hold the boot block button on the circuit board as shown. Continue to hold down the boot block button through Step 9.

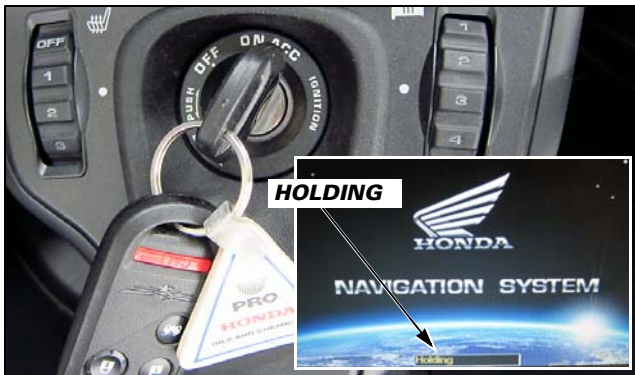
6. While holding the boot block button down, turn the ignition switch to the ACC position. *Holding* should be shown on the navi display. Keep holding the boot block button down.

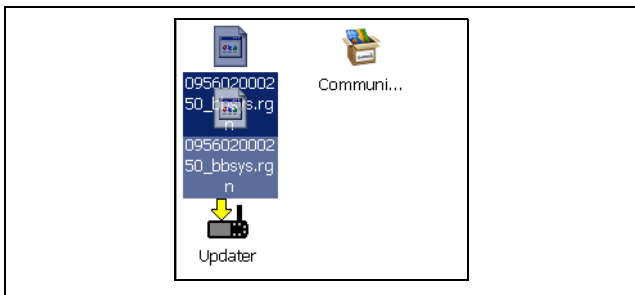
7. On the PC, drag and drop the file icon for *095602000250_bbsys.rgn* onto the file icon for *Updater*.

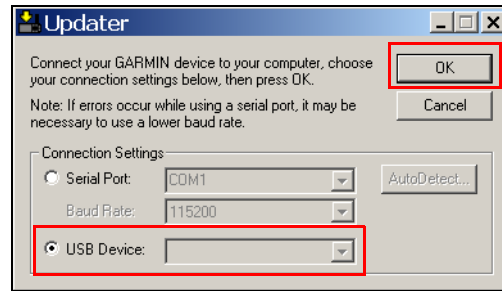
8. The *Updater* dialog box will open. Select *USB Device* and then click *OK* as shown. Keep holding the boot block button down during the navigation software update.

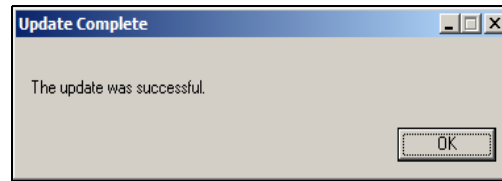
9. Wait for the *Update Complete* message to be displayed on the computer, then release the boot block button.

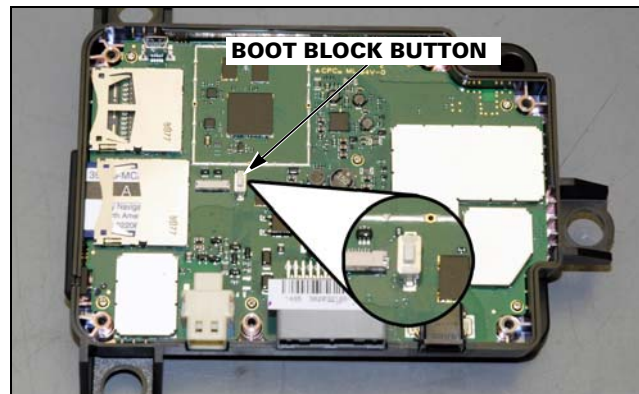
10. Disconnect the USB Mini B connector from the navigation unit. Then press and release the boot block button after the navigation system has started.

- If the navigation system fails to start (black screen), press the *Map* key on the navigation switch panel, let the system boot up, then press the boot block button.
